Delivery Order 9 Enhanced Preliminary Assessment

FORT DEVENS, MASSACHUSETTS

April 1992

ENHANCED PRELIMINARY ASSESSMENT

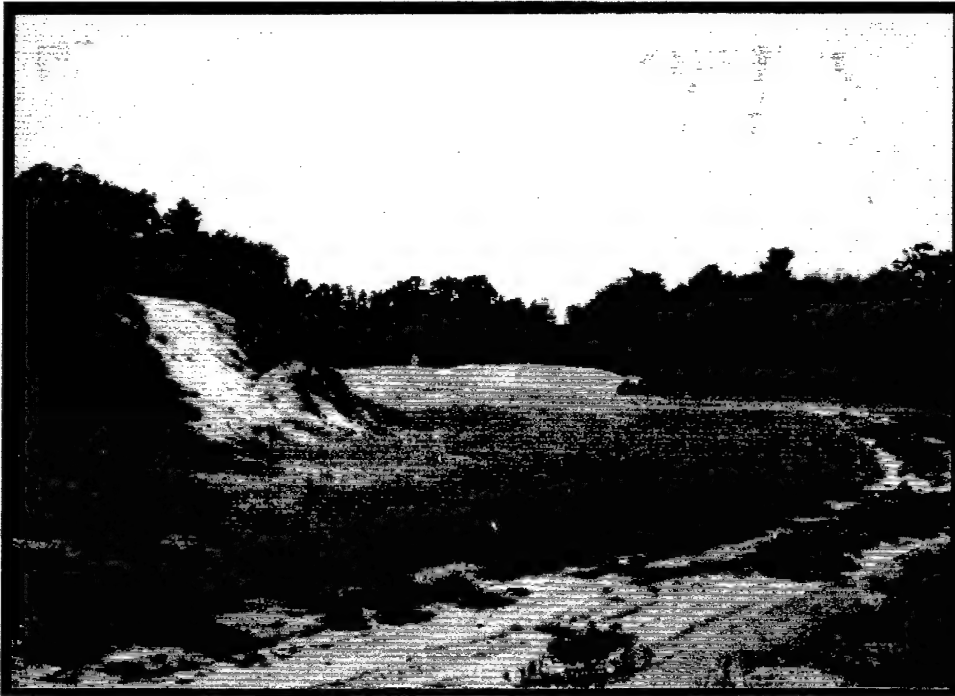
3. AREE 5 - SHEPLEY'S HILL LANDFILL (NO.1)

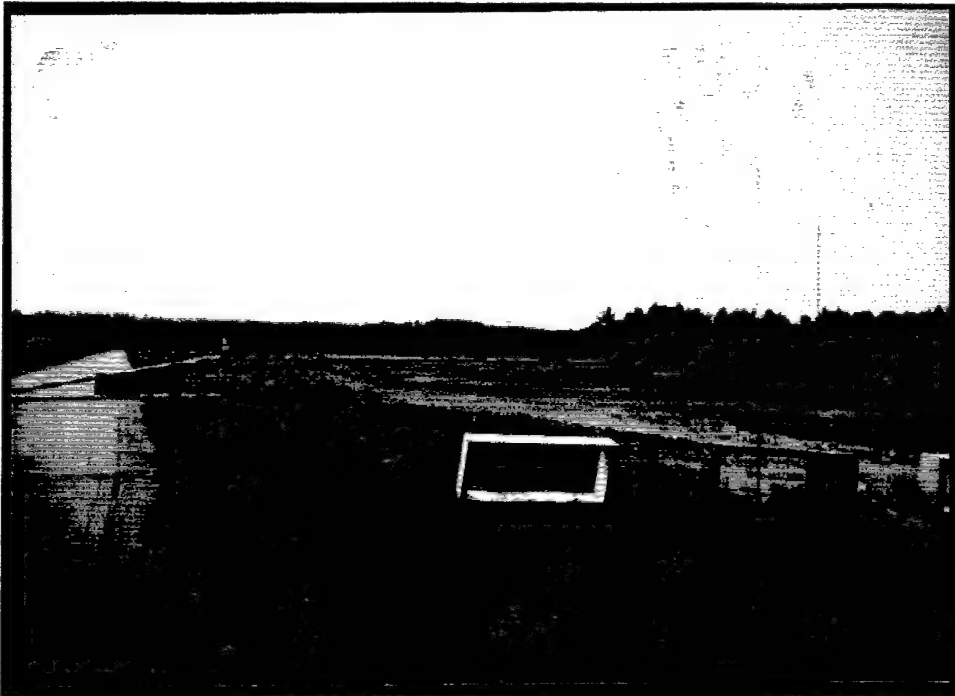
5. AREE 14 - FORMER QUARRY AS LANDFILL NO. 10

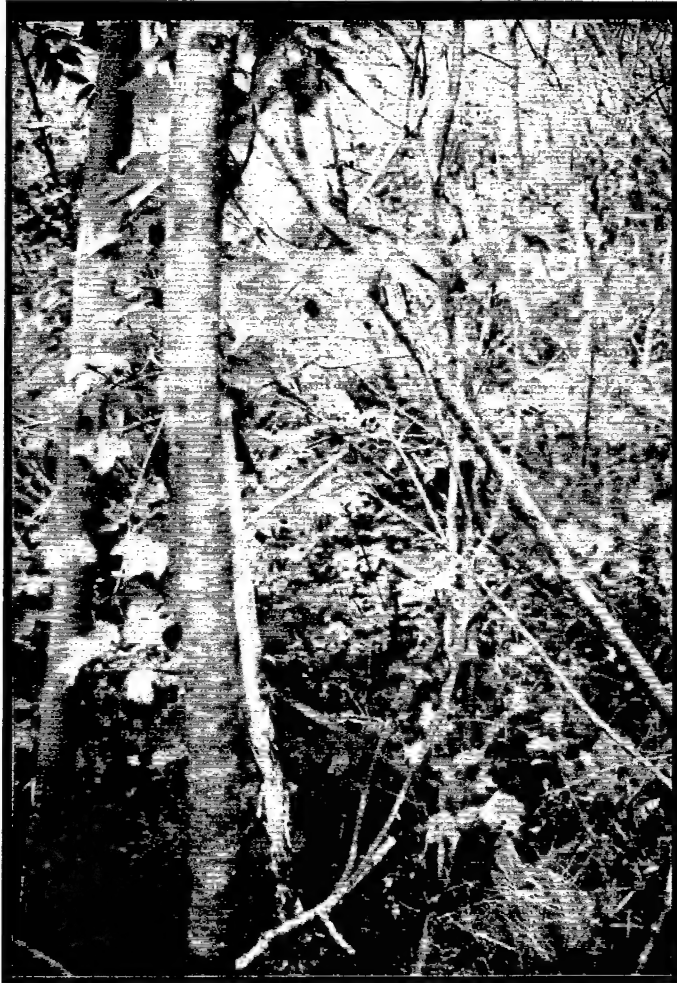
7. AREE 16 - GENERAL CONDITIONS AT LANDFILL NO. 12

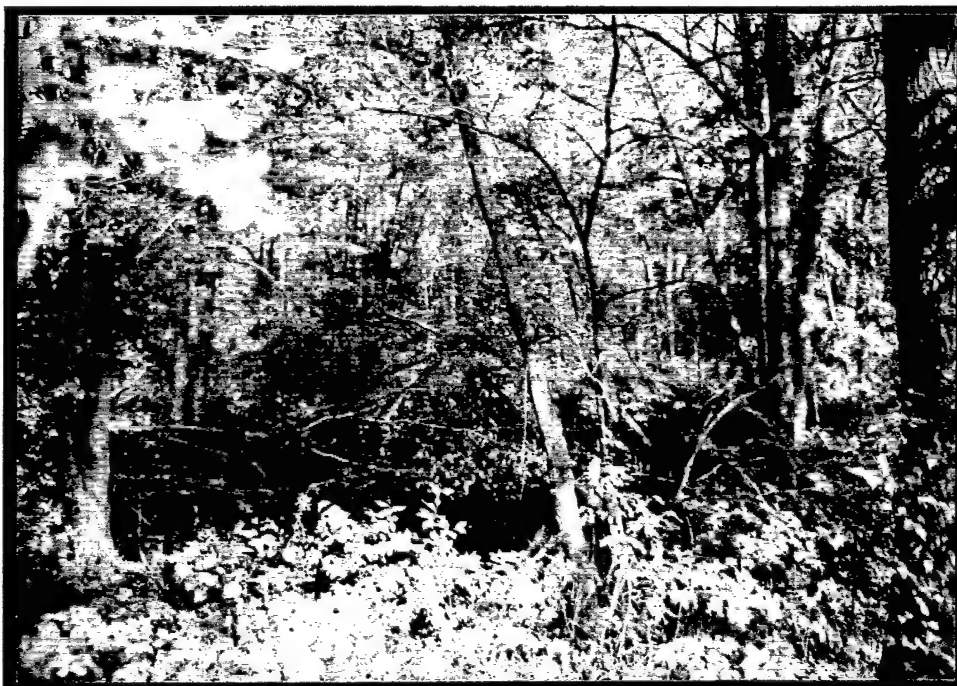
**8. AREE 40 - GENERAL CONDITIONS AT
COLD SPRING BROOK LANDFILL**

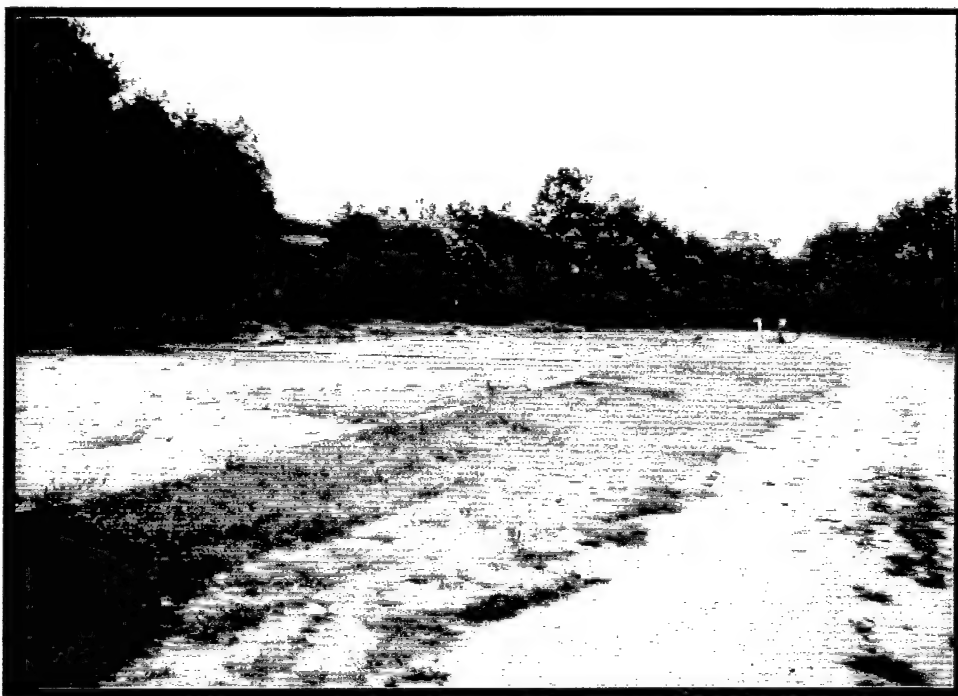
11. AREE 20 - TYPICAL RAPID INFILTRATION BASIN

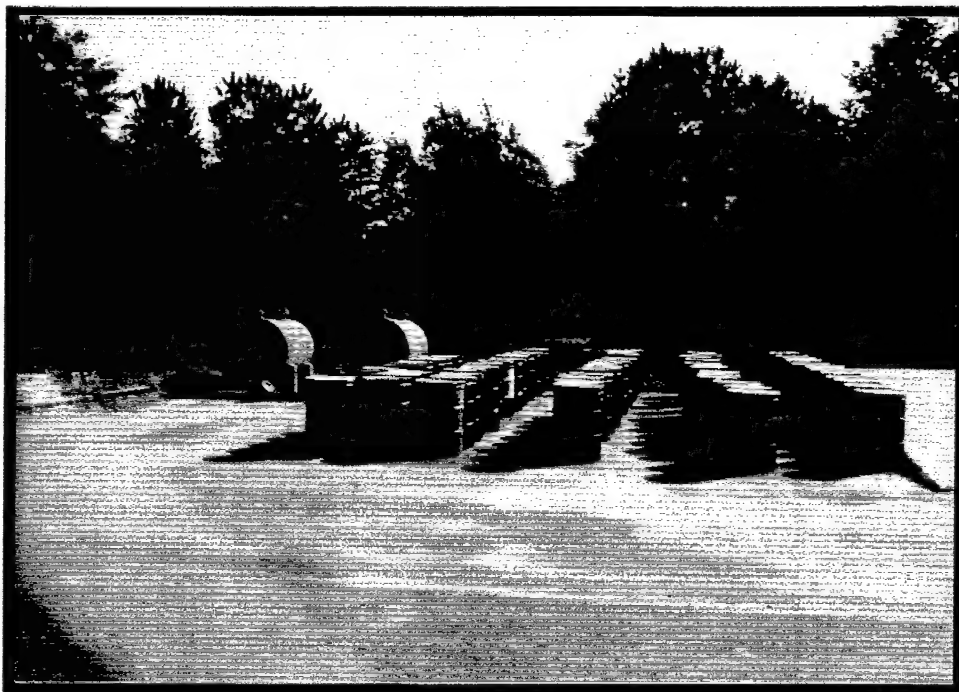
12. AREE 21 - SLUDGE DRYING BEDS

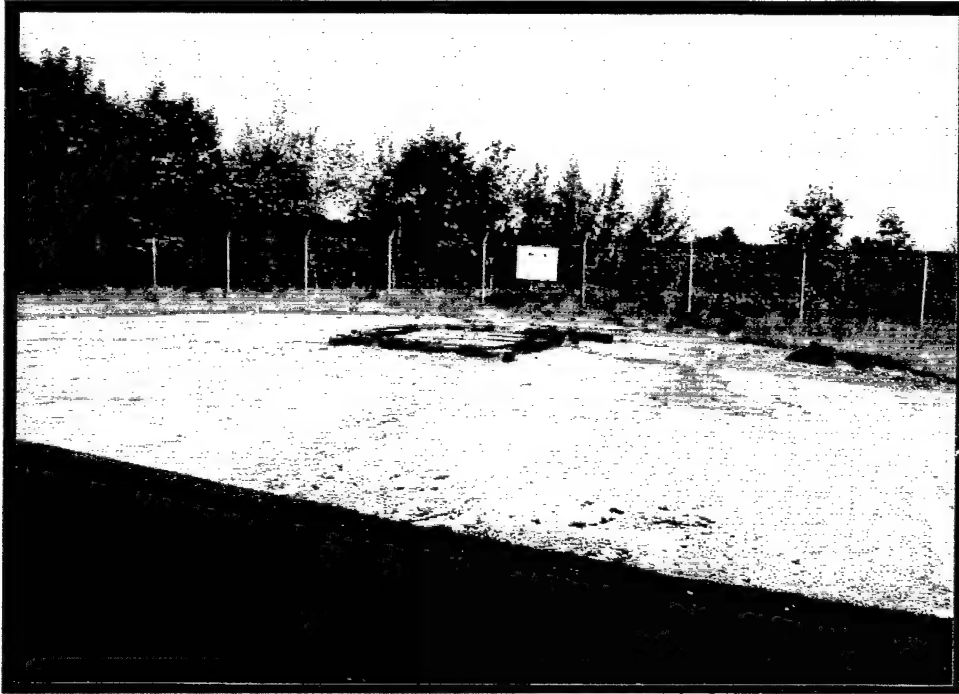
13. AREE 22 - DRUMS LOCATED BEHIND HAZARDOUS WASTE STORAGE FACILITY (BUILDING 1650)

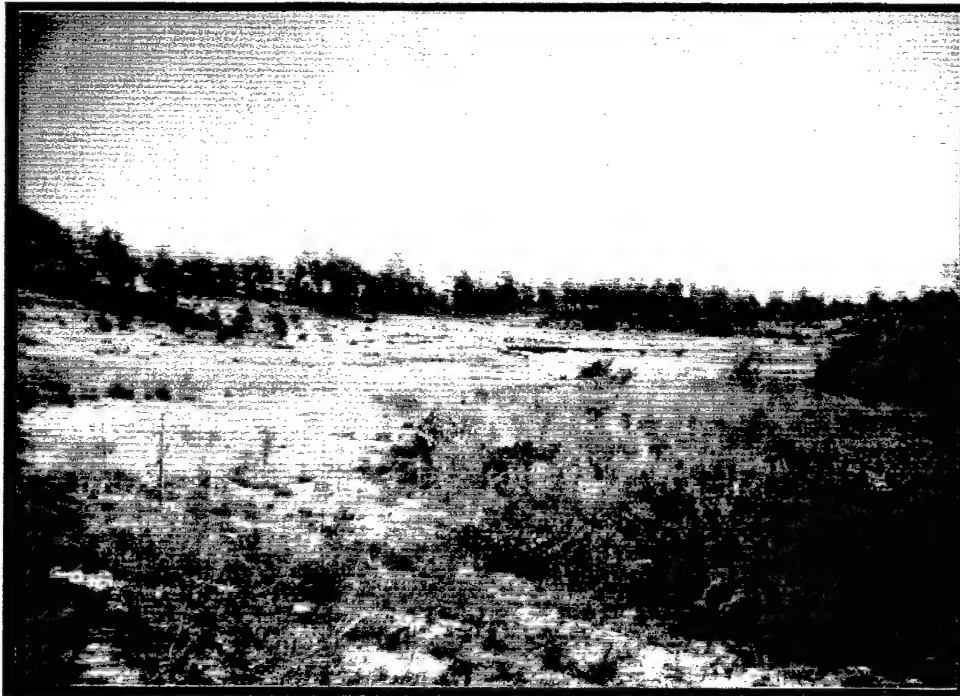
15. AREE 25 - TYPICAL CONDITIONS AT EOD RANGE

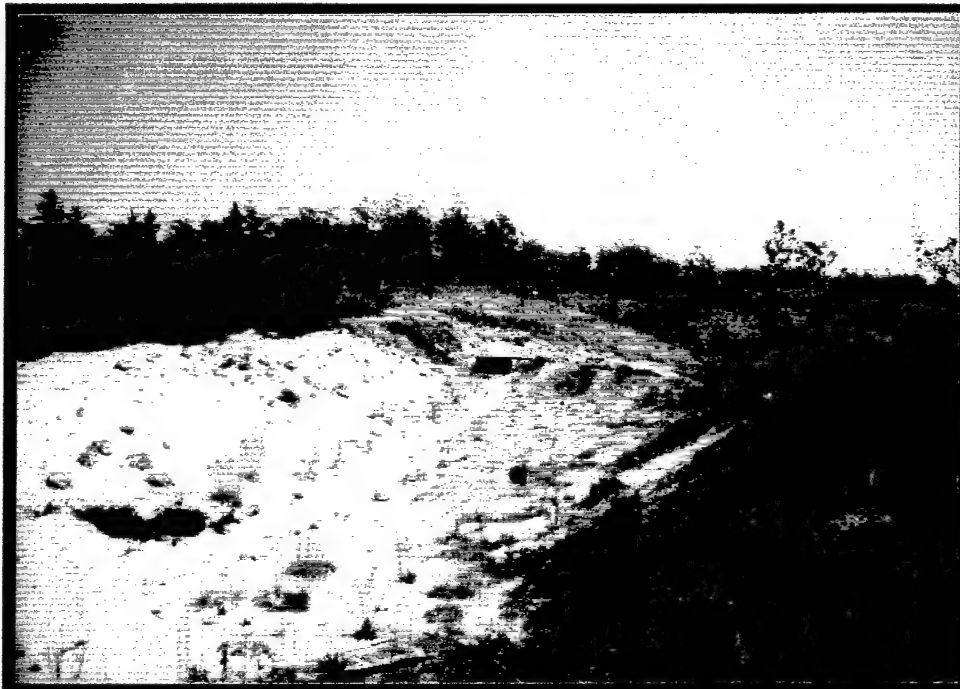
16. AREE 26 - TYPICAL CONDITIONS AT ZULU I RANGE

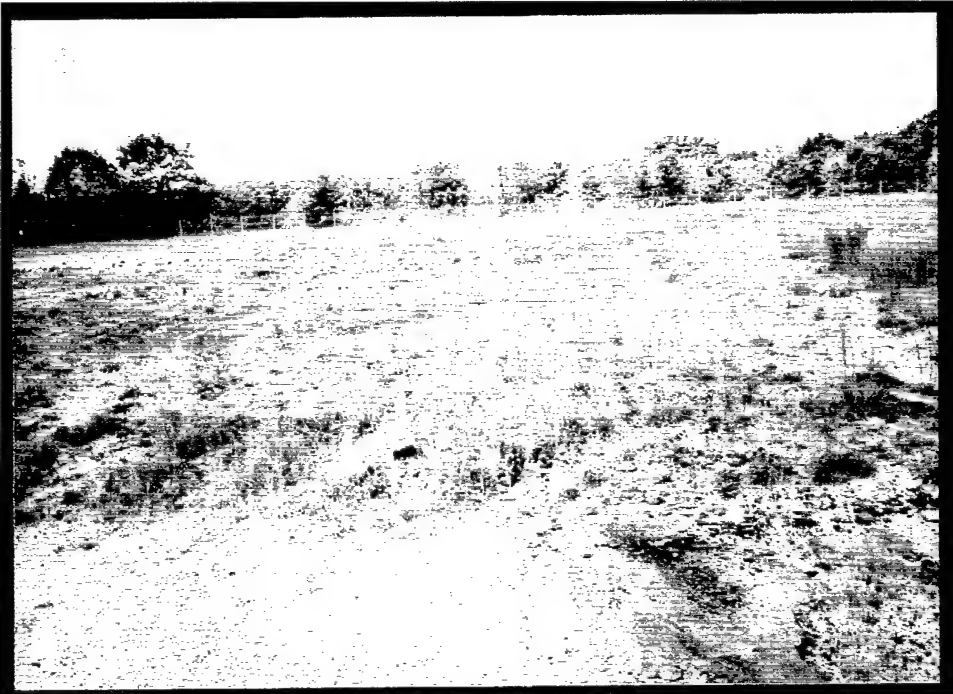
17. AREE 26 - TYPICAL CONDITIONS AT ZULU II RANGE

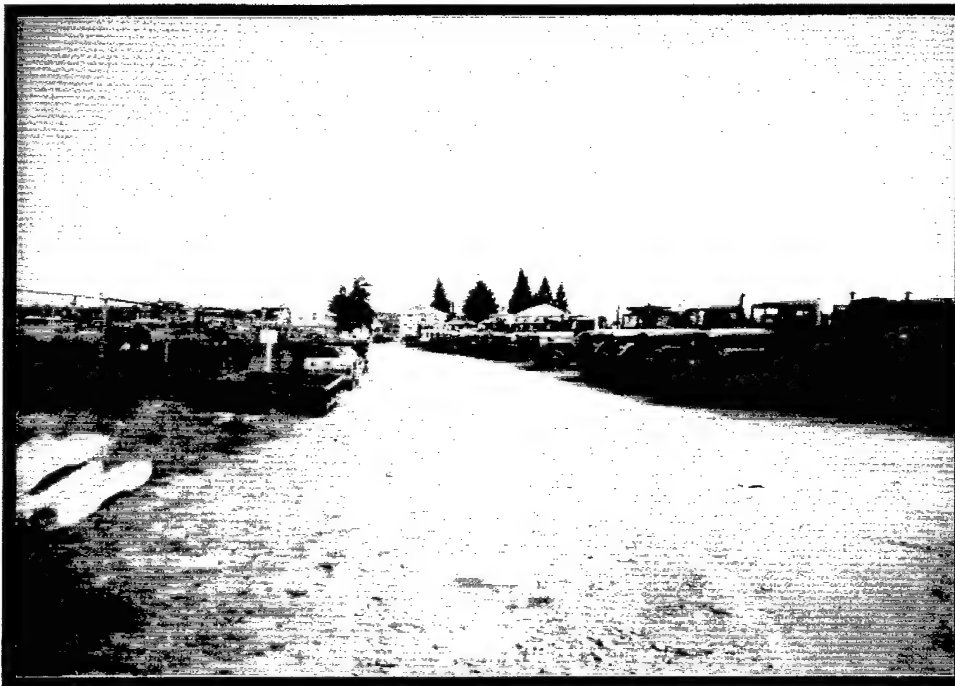
20. AREE 50 - WWII ERA LUST SITE NEAR MAAF

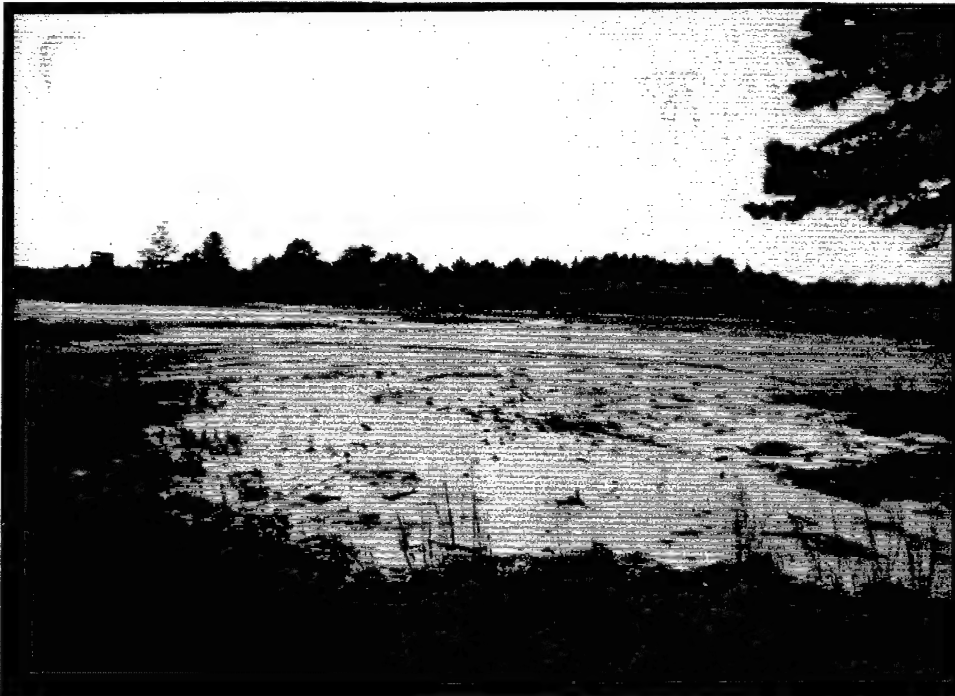
21. AREE 52 - GENERAL CONDITIONS AT THE TDA MAINTENANCE YARD

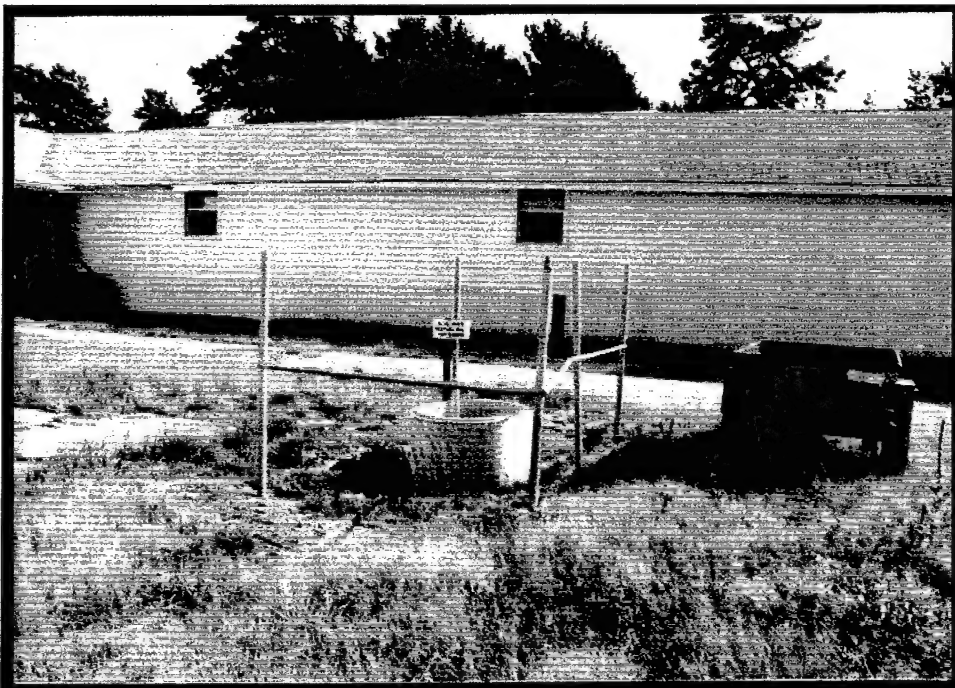
22. AREE 53 - CURRENT CONDITIONS AT TYPICAL POL SPILL SITE
